PHASE II ENVIRONMENTAL BASELINE SURVEY OF McCORMICK RANCH, KIRTLAND AIR FORCE BASE, NEW MEXICO

Part 1 of 5

Final Report

PL-TR-95-1042

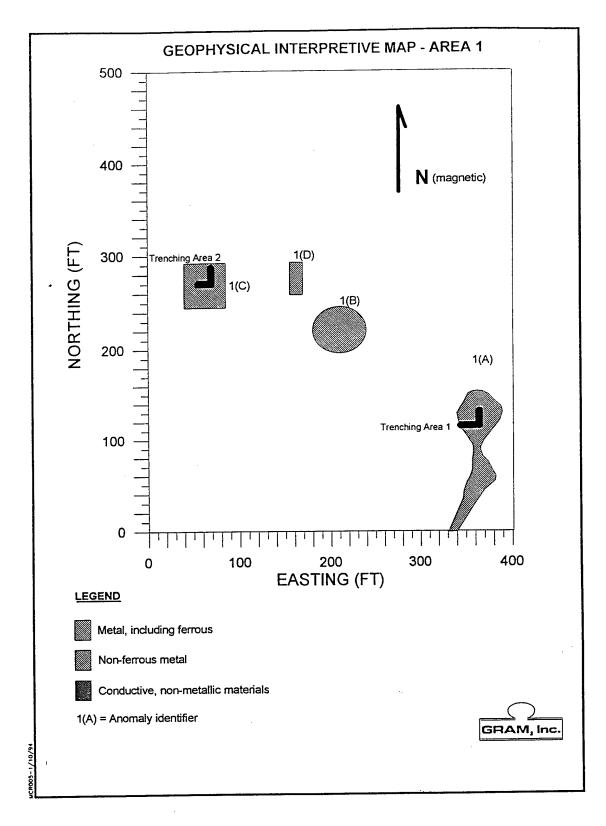
Figure 2.2 Interpretive Map of Geophysical Area 1

Anomaly 1(A) is centered at approximately 370E, 90N, with approximate dimensions of 50 feet (east-west) and >170 feet (north-south) (Figure 2.1 and Table 2.3). This anomaly is related to buried metal, including ferrous metals. GPR profiles indicate that there is a subsurface disturbance (trench or crater) from approximately 10 feet to greater than 15 feet deep, and subsurface cracks associated with this anomaly. Figure 4.1 presents a GPR transect across Anomaly 1(A), showing a covered trench or depression. A broad surface depression is present in this zone, and is interpreted to be related to soil subsidence. This anomalous zone was interpreted to be the location of one of the HEST Tests. Field reconnaissance with people who had first-hand knowledge of testing activities confirmed this interpretation. For these reasons, anomaly 1(A) was selected as the location for Trenching Area 1 (see Section 2.2.1.1).

Anomaly 1(B) is centered at approximately 210E, 220N, and has dimensions of approximately 50 feet (north-south) by 60 feet (east-west) (Figure 2.2 and Table 2.3). This anomaly is related to buried metal, including ferrous metals. GPR profiles in this area indicate that the anomaly is related to a small, discrete buried object from approximately two feet to three feet deep. There was no evidence of trenching or cratering associated with this anomaly.

Anomaly 1(C) is centered at approximately 60E, 270N, and has dimensions of approximately 50 feet (north-south) by 50 feet (east-west) (Figure 2.2 and Table 2.3). This anomaly is related to buried metal, including ferrous metals. GPR profiles over this anomaly identified a covered trench or crater greater than approximately eight feet deep, and subsurface cracks, apparently related to testing activities. Figure 4.2 presents a GPR transect across Anomaly 1(C), showing

subsurface cracks. A broad surface depression is present in this anomalous zone, and is interpreted to be related to soil subsidence. Field reconnaissance with people who had first-hand knowledge of testing activities confirmed the interpretation that this zone was the location of one of the HEST tests. For these reasons, anomaly 1(C) was selected as the location for Trenching Area 2 (see Section 2.2.1.1).

Anomaly 1(D) is located at approximately 160E, 275N, and has approximate dimensions of five feet (east-west) and 20 feet (north-south) (Figure 2.2 and Table 2.3). This anomaly was detected with the in-phase output of the EM 31 instrument, but not by the magnetometer. This indicates that this anomaly is related to buried, non-ferrous metals. GPR profiles collected over this anomaly showed a small amount of buried debris and some subsurface cracks. This anomaly is interpreted to be related to testing, but no subsurface craters or depressions were identified. This anomalous zone was selected as a location for hand-auger sampling.

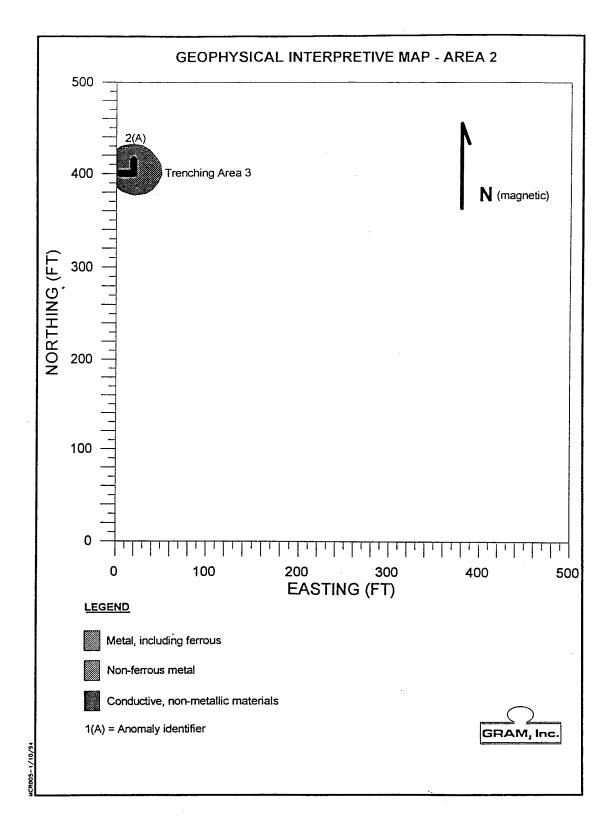
Figure 2.3 Interpretive Map of Geophysical Area 2

A single anomalous zone, Anomaly 2(A), was detected in the northwest corner of this Area (Figure 2.3). This anomaly is located at approximately 20E, 410N, and has dimensions of greater than 60 feet (east-west) by 75 feet (north-south). This geophysical anomaly was detected with the quadrature component of the EM 31 instrument, which measures soil conductivity. No anomalous readings were present in the magnetic or EM 31 in-phase data in this zone. Therefore, this anomaly is interpreted to be related to conductive, non-metallic materials (i.e., high soil electrical conductivity). GPR profiles collected over this zone show disturbed soils and a subsurface depression, interpreted to be related to a covered trench or crater. A broad surface depression is present in this anomalous zone, and is interpreted to be related to soil subsidence. Although the specific testing activities that created this feature are not known, Anomaly 2(A) was selected as the location for Trenching Area 3 based upon results of the geophysical investigations (see Section 2.2.1.1).

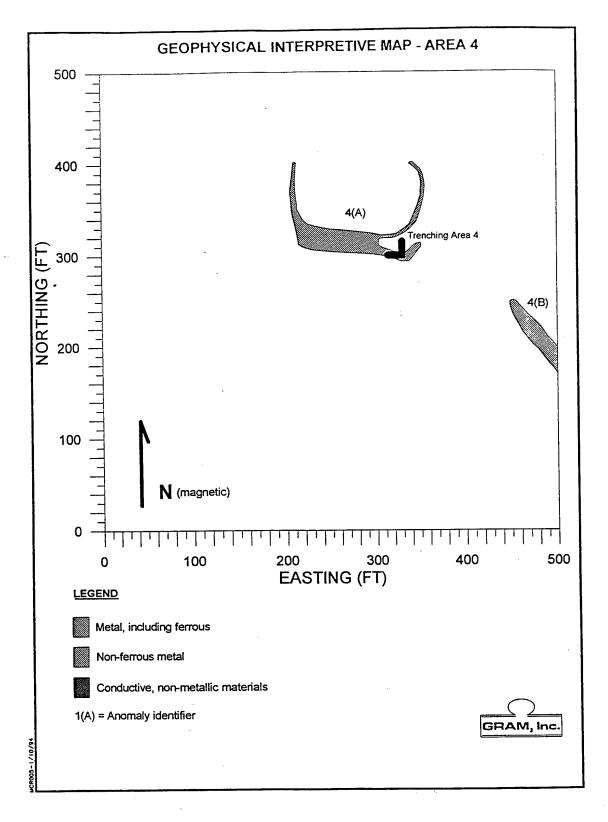
Figure 2.4 Interpretive Map of Geophysical Area 4

Geophysical Area 4: Geophysical surveys located large quantities of test debris (buried metal and cables) in Geophysical Area 4, possibly related to the Bomb, CHEBS, and Mini Sim Quake tests. Site reconnaissance also located visible evidence of several trenches, mounds, and craters with associated test debris (cement, metal, and cables) in and around the borders of the gridded area. Although one trenching area is located in the central portion of Geophysical Area 4, 20 additional hand-auger soil samples were collected to more thoroughly evaluate the soils within this area. Test materials known to have been used in the area include: RDX, motor oil, PETN, TNT, aluminum, steel, wiring, and cables. Two linear depressions at the northwest corner of the area, possibly associated with the Mini Sim Quake test (the largest test conducted at McCormick Ranch), were investigated. Soil samples were also collected to the northwest of Trenching Area 4 in an area where buried debris was identified during the geophysical surveys (Table 2.1 and Figure 2.3). Additional soil samples were collected in the surface depression northeast of the area because it was reported to be a small precursor test to the Mini Sim Quake test.

Anomaly 4(A) is a large semi-circular anomaly centered at approximately 280E, 370N, with approximate dimensions of 180 feet (east-west) by 130 feet (north-south) (Figure 2.4 and Table 2.3). This anomaly was detected with the EM 31 in-phase measurements, but not with the magnetometer. Therefore, this anomaly is interpreted to be related to buried, non-ferrous metal. GPR profiles collected over this anomalous zone show buried debris and disturbed soils from near the surface to approximately 10 feet deep. Buried debris was detected along the semicircle and in the center. The non-ferrous metal detected in this anomalous zone is interpreted to be wiring and instrumentation related to testing activities. This anomalous zone was selected as a location for Trenching Area 4 (see Section 2.2.1.1).

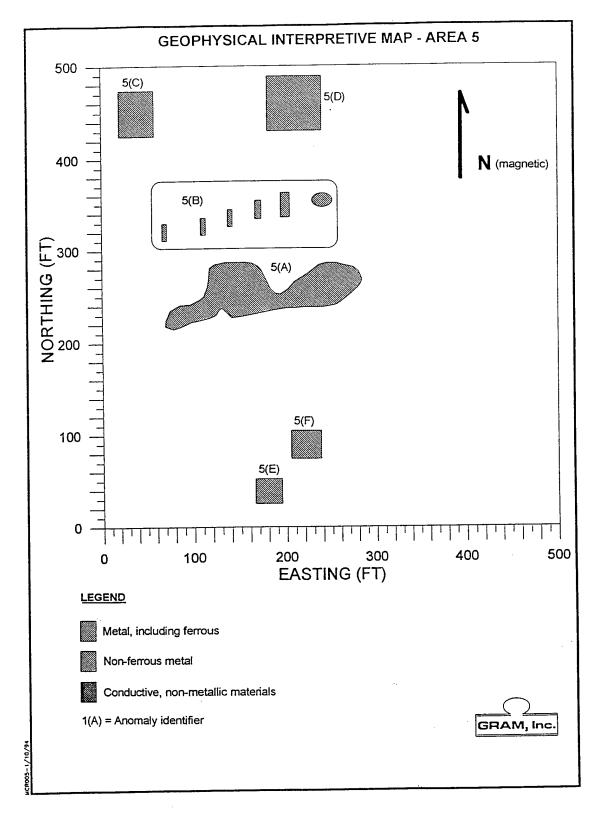
Figure 2.5 Interpretive Map of Geophysical Area 5

Anomaly 5(C) is centered at approximately 40E, 450N, with approximate dimensions of 40 feet (east-west) by 45 feet (north-south) (Figure 2.5 and Table 2.3). This anomalous zone is interpreted to be related to buried metal, including ferrous metals. GPR profiles over this anomaly detected two discrete buried targets at an approximate burial depth of three feet to four feet, as shown in Figure 4.3. This anomalous zone was selected as a location for hand-auger soil sampling.

Anomaly 5(D) is centered at approximately 210E, 460N, with approximate dimensions of 60 feet (east-west) by 60 feet (north-south) (Figure 2.5 and Table 2.3). This anomalous zone is interpreted to be related to buried metal, including ferrous metals. GPR profiles over this anomaly did not detect any buried targets.

Two additional small anomalies were identified in Area 5. Anomaly 5(E), centered at approximately 180E, 40N, was determined to be related to a metal object (geophone) on the surface during final field reconnaissance. Anomaly 5(F), centered at 220E, 90N with dimensions of 30 feet (east-west) by 30 feet (north-south), is related to buried metal including ferrous metals (Figure 2.5 and Table 2.3). GPR profiles over this zone identified small, discrete buried targets from the near-surface to approximately two feet deep, but no evidence of trenching or cratering was indicated.

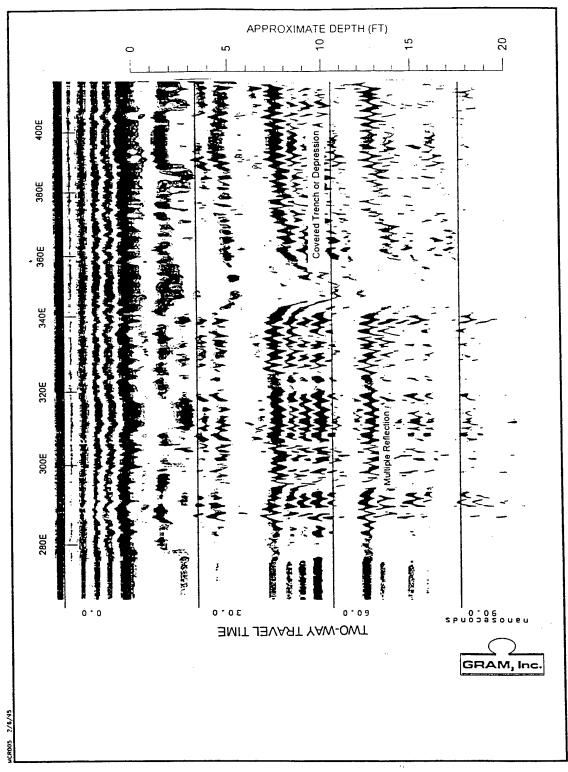
Figure 4.1 Area 1, Anomaly 1(A): West-East GPR Transect Along Line 140N Showing a Covered Trench or Depression

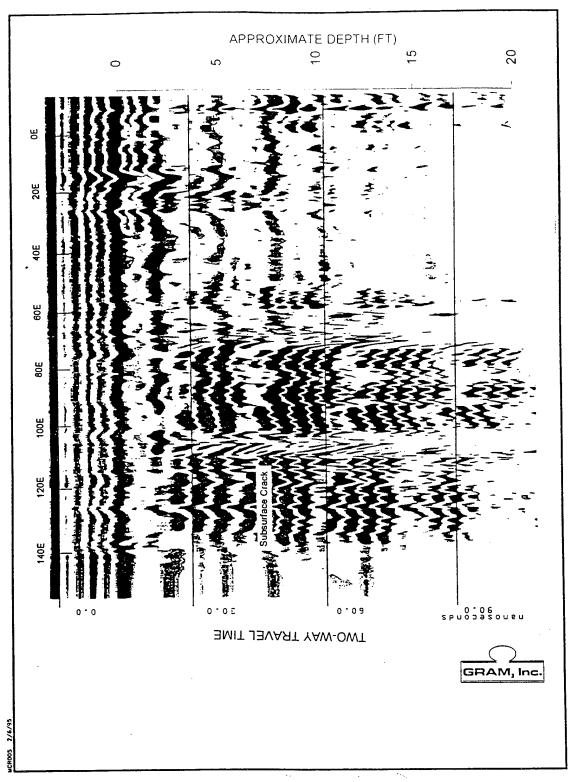
Figure 4.2 Area 1, Anomaly 1(C): East-West GPR Transect Along Line 260N Showing Subsurface Cracks

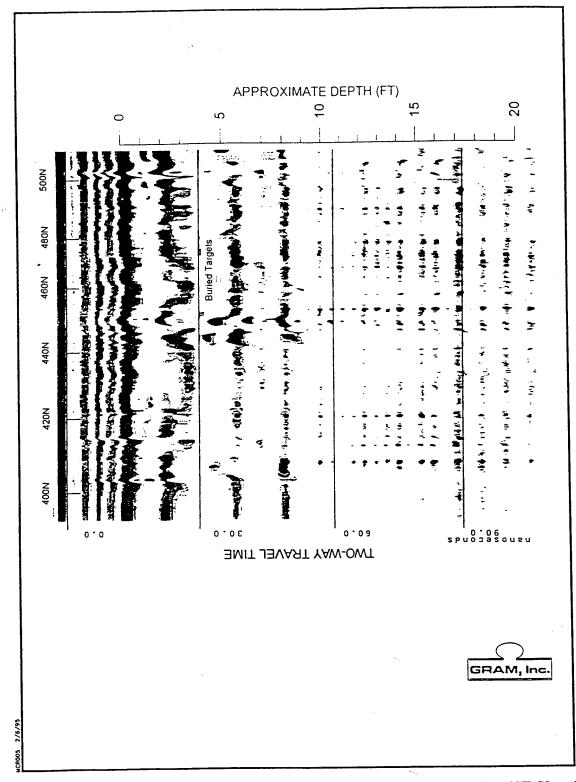
Figure 4.3 Area 5, Anomaly 5(C): South-North GPR Transect Along Line 40E Showing Buried Targets

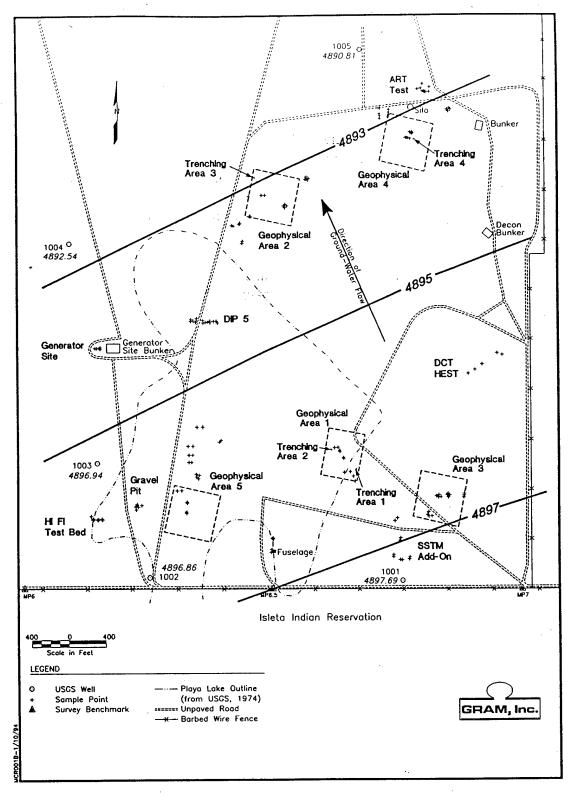
Figure 2. Water Table Contour Map, October 25, 1994

The depth to the water table is approximately 350 to 380 feet below ground surface. Monthly water levels were measured from June of 1992 through December of 1993 by the USGS. Water levels were measured in the five wells for the Phase II EBS on October 26, 1994. Table 1 shows the water level elevations for this date. A water level contour map of these measurements is shown on Figure 2. The water-level elevations shown are derived from the recent land survey performed at the site for the Phase II EBS. Top-of-casing elevations from the Phase II EBS survey were consistently lower (by up to four feet) than the survey results from the Kirtland AFB IRP investigation (USGS, 1993). If additional wells are installed at the site the existing wells should be resurveyed. Regardless of the survey reference used, the groundwater flow direction is to the north. The hydraulic gradient is 0.001.

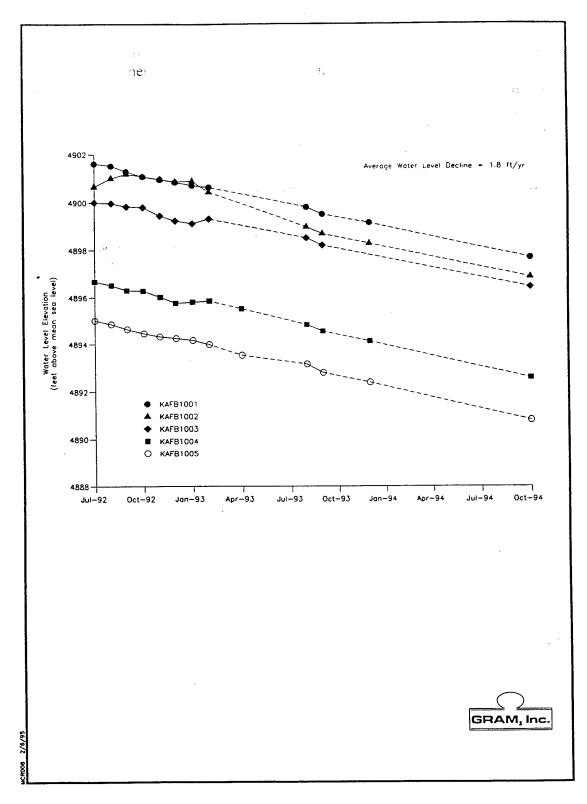
Figure 3. Hydrographs of Water Level Elevations for Monitoring Wells

Water level decline at McCormick Ranch before 1992 is unknown due to lack of data in that area. However, water levels during 1992-1994 are declining steadily at about 1.8 ft/yr in the five RFI wells. Wells at the CWL and MWL show a similar rate of decline from 1986 to the present. Figure 3 shows decreasing water levels over time in all five of the McCormick Ranch monitoring wells. This trend is consistent with a one-half- to two-foot decline in water levels at wells on

Kirtland AFB presumably caused by groundwater pumping from the Albuquerque and Kirtland AFB well fields. As discussed in Section 2.3, the Albuquerque and Kirtland AFB production wells are located near the northern boundary of Kirtland AFB.
